CRS S-8496
Not Eligible
Plate 214; Appendix A, Plat 25

This small, rectangular plan, one story, gable roofed cottage is situated on the east side of Road 30, south of Gravel Hill. The house is three bays wide and two bays deep with a rear, one bay deep, shed roofed addition. The pedimented entry is centrally placed in the west or front facade, facing the road. The doorway is flanked by a modern, one over one, double hung window and a large, picture window. A rear entrance is located in the middle of the east facade. A modern, exterior, brick chimney is placed along the north facade. The house sits on a concrete foundation and is clad in blue, composition shingle siding. Two sheds, one of which is modern, are present at the rear of the property. This house appears to have been built after 1945, and lacks individual architectural merit or known historical significance, thus it is ineligible based on National Register criteria.

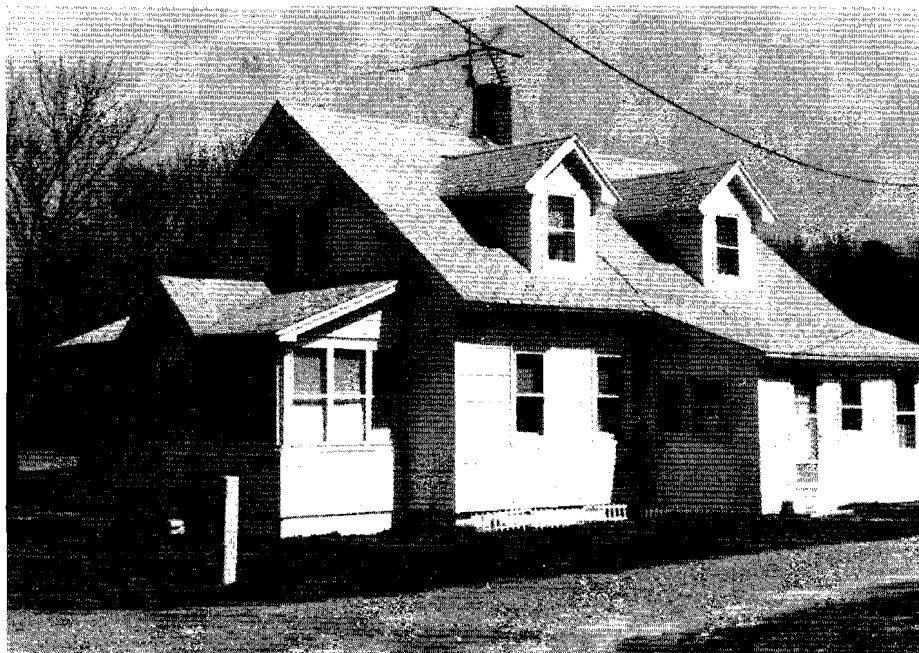
PLATE 244: CRS S-8510
View of cottage looking northeast.

This house appears to date to the 1930s or 1940s. The building is not eligible due to various alterations including changes in the fenestration, the enclosure of the front porch, and the construction of an addition on the south facade. The house is a common style found throughout the study area, and lacks individual architectural distinction.

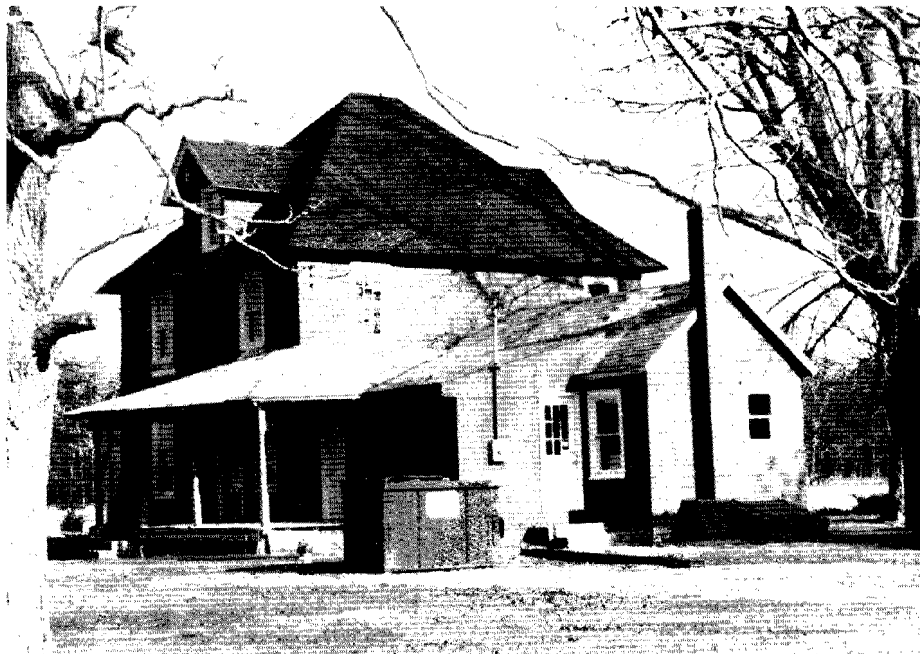
CRS S-3024
Previously Surveyed
R.H. Vassallo Wood Products
Eligible: Classical Box, Multiple Property Submission
Figure 8; Plate 245; Appendix A, Plat 30

PLATE 245: CRS S-3024
View of house looking northeast. Note hipped roof and projecting dormers.

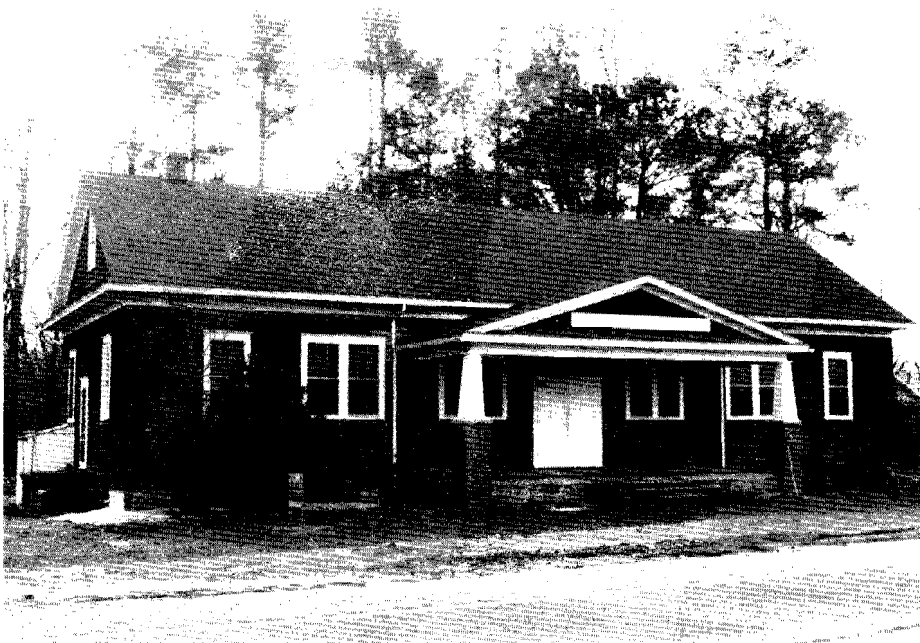
PLATE 246: CRS S-3025
View of Cool Spring Community Building looking south. Note wood shingle siding and six over one windows.

This building appears to be an individually eligible structure. It is the only building of its kind in the project corridor and is in excellent condition. According to a previous survey, this building resembles the DuPont schools constructed throughout Delaware in the 1920s and 1930s; although, according to the plaque on the building it was constructed for use as a community hall, and not a school (Taylor 1983). The structure does not appear to have been altered in any way since its construction. It is a unique example of an early twentieth century public building in rural Sussex County. The building is significant within the temporal period 1880-1940, and within the historic context of Community Organizations/Education.

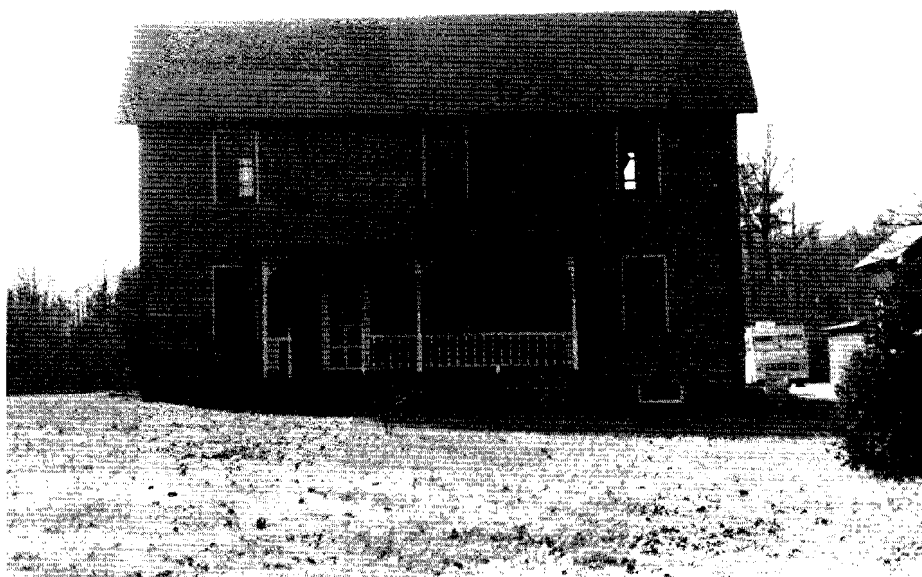
PLATE 248: CRS S-855

View of north facade of house. Note the insertion of the doorway in the facade, creating a four bay house, rather than a three bay dwelling.

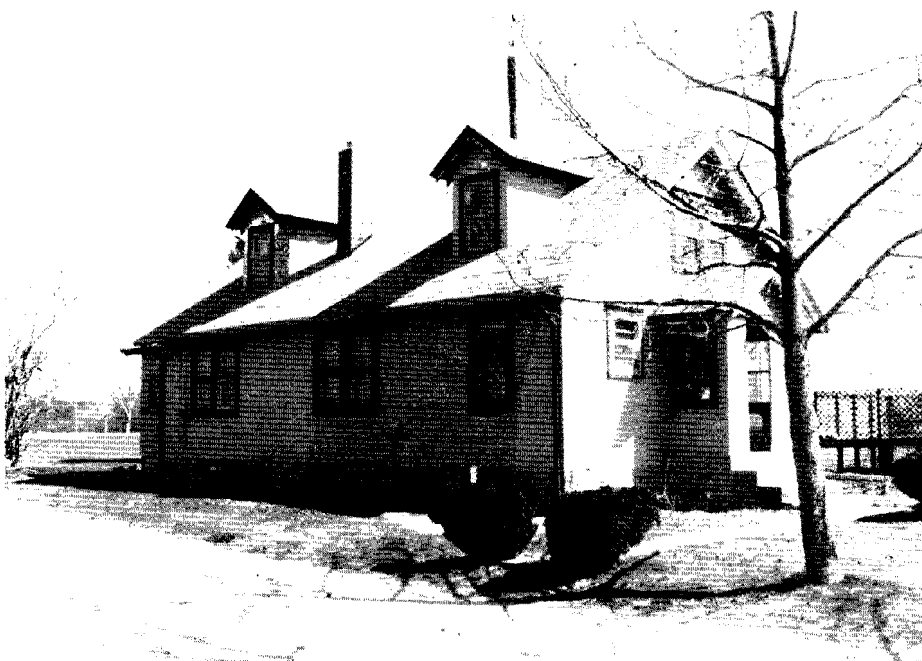
PLATE 249: CRS S-856

View of house looking northeast.

This dwelling complex is not eligible. The house has been completely renovated within the last three years and has all new windows, doors, and siding as well as a new foundation. The fenestration on the main facade has been altered with the insertion of a door in the first story, changing it from a symmetrical, three bay I-house to an asymmetrical, four bay I-house. There are better examples of the three bay style with greater integrity and in their original location, throughout the project corridor.

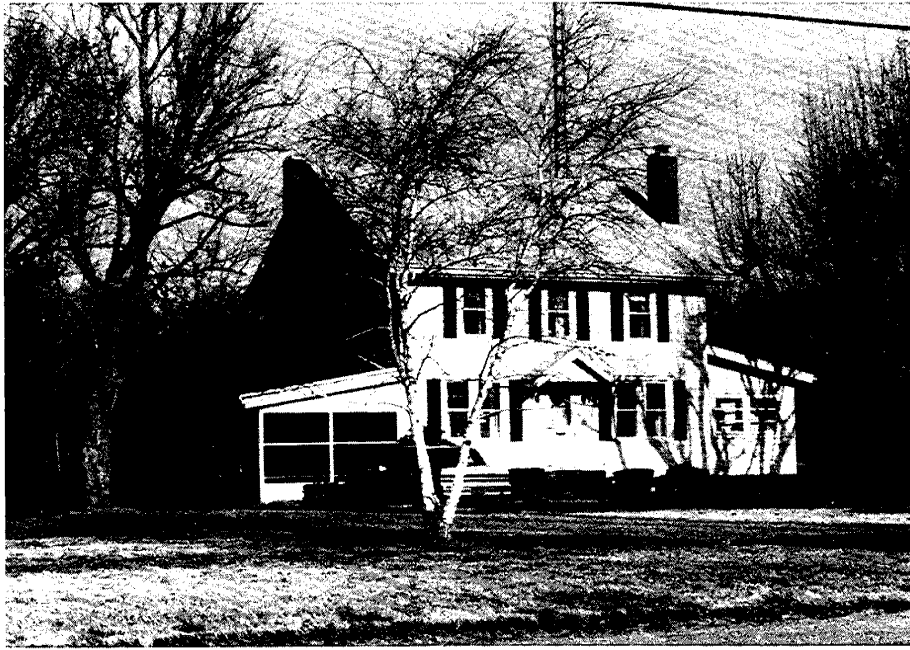
PLATE 250: CRS S-8512
View of house looking north.

A large, one story, two bay wide addition with a flat roof extends across the entire north facade of the house. This addition has one over one, double hung windows with louvered shutters. It sits on a raised concrete foundation. The addition is clad in white, aluminum siding as is the rest of the house.

This property is not eligible. Although the house is in good condition, it has been significantly altered through various additions and changes in fenestration. There are a handful of Colonial Revival houses in the project area, most of which lack individual architectural or historical significance. These houses do not form a justifiable multiple property submission. Two of the outbuildings are modern, and the barn has been altered with modern doors and the application of aluminum siding.

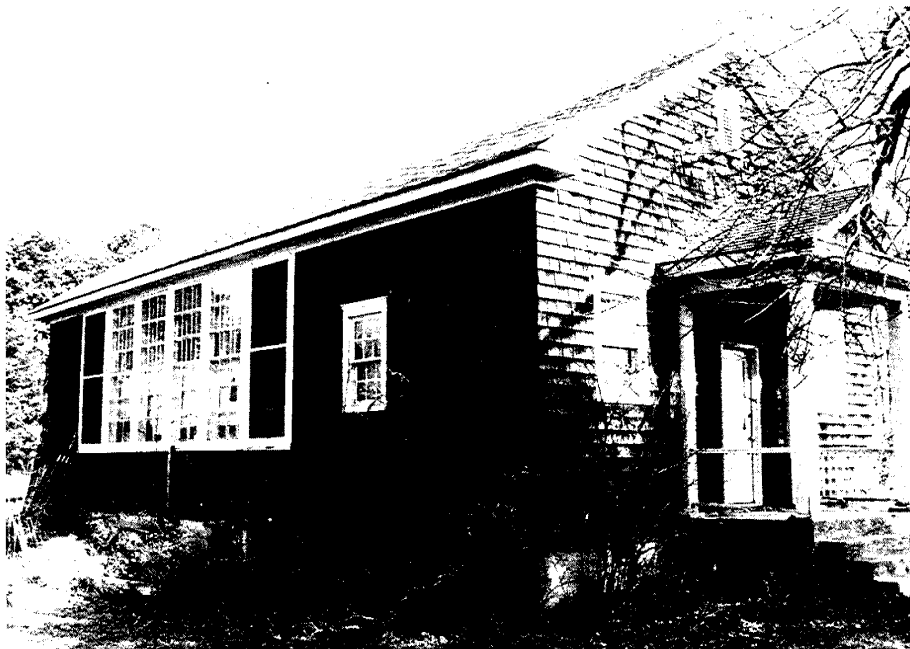
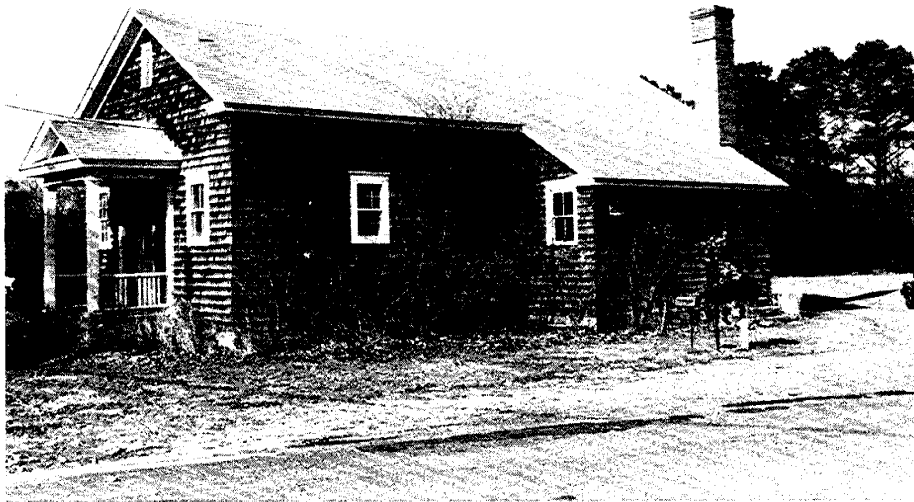
The "Drawbridge School," as it is called by locals, is in excellent condition and does not appear to have been altered from its original appearance. A historic photograph dating from 1923, the year construction was completed on the building, shows the west and south facades (See front cover of report). Except for the application of wood shingle siding, these facades

PLATE 251a: CRS S-739
View of Drawbridge School looking northeast. Note large, nine over nine windows in the west facade and wood shake shingle siding.

PLATE 251b: CRS S-739
View of Drawbridge School looking west. Note pedimented entry porch.

are identical to the way the building looks today (Delaware State Archives). The north or rear facade of the building does however, currently have a shed roofed porch with a large, garage type opening. It appears that this area was used as some type of a "loading dock" at one point in the building's history. Although it is a substantial alteration to the facade, it does not detract from the overall appearance of the school when viewed from Route 404.

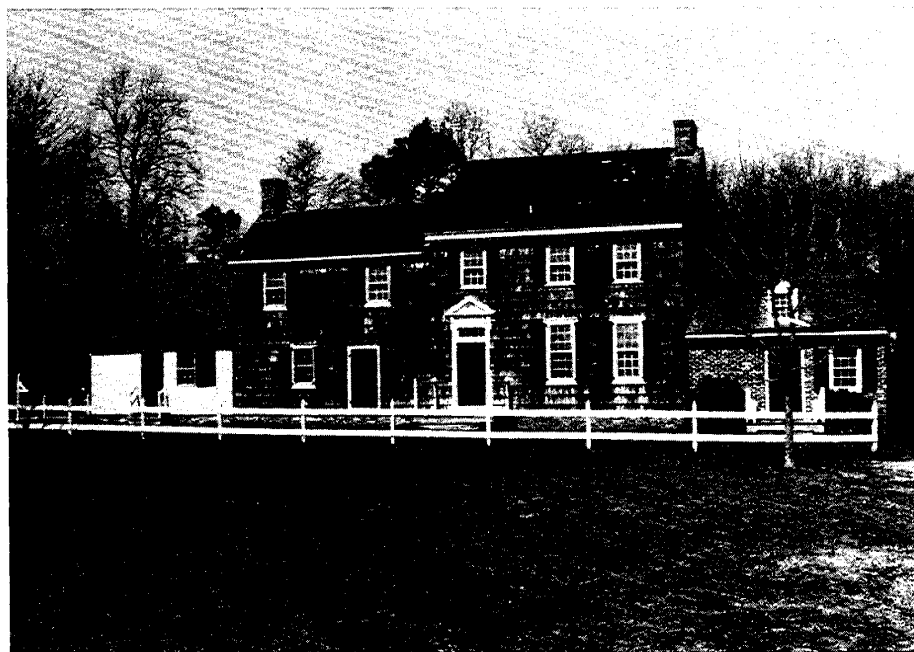
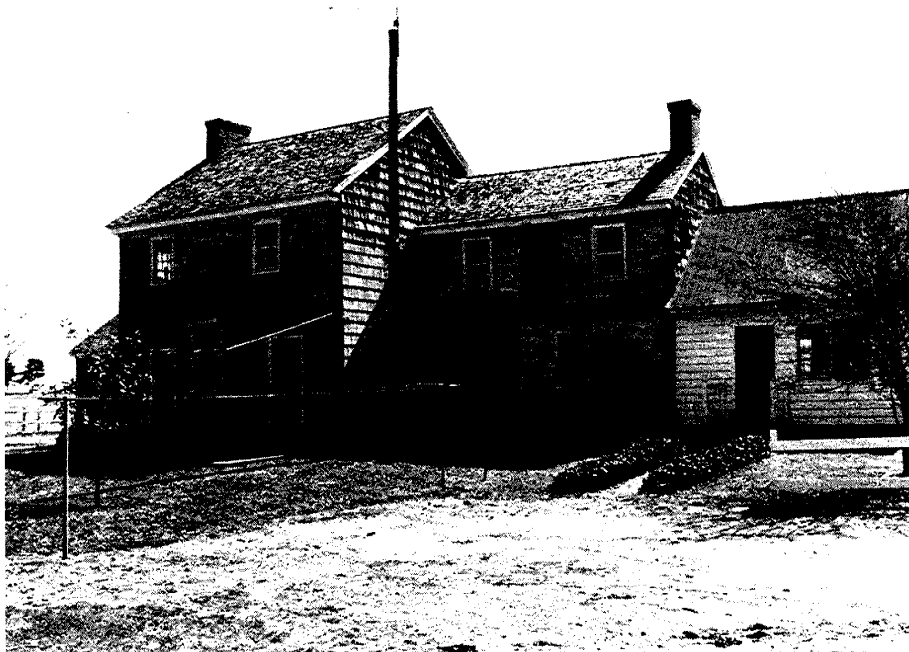
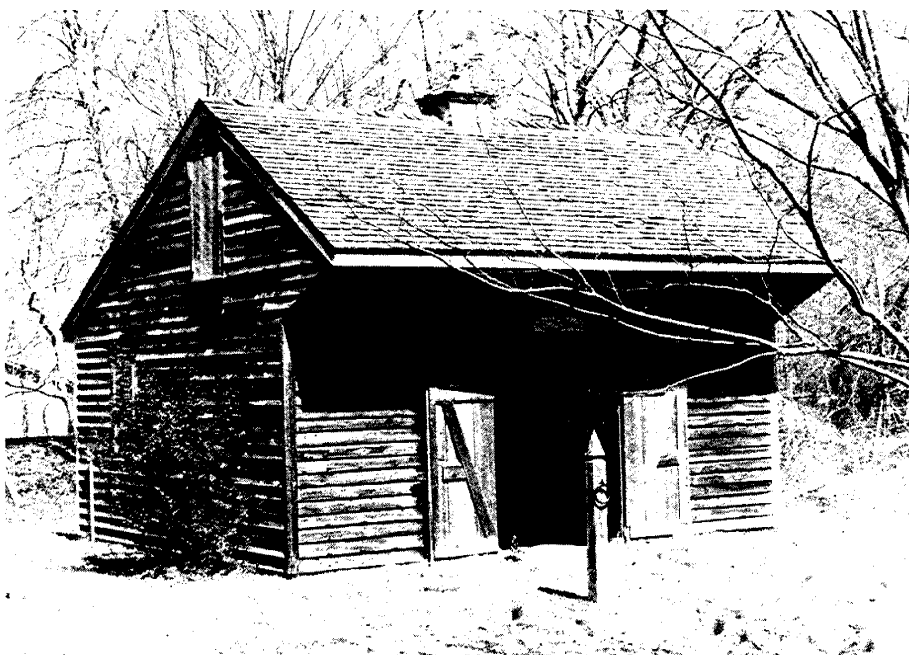
PLATE 252a: CRS S-858
View of front facade. Note four distinct sections of the house.

PLATE 252b: CRS S-858
View of rear facade looking south.
Note dentil cornice on the largest section and six over six windows.

PLATE 252c: CRS S-858
View of frame stable at the rear of the property.

The house is currently for sale. A conversation with the real estate agent for the property revealed that the earliest portions of the house supposedly date to the eighteenth century. According to the agent, the current owner, Gary Hoffman, completely restored the house himself (Personal Communication with Jack Lingo, March 1991). Although the house is in excellent condition, it is not possible to determine how much of the building is original, and how much has been added by the owner during restoration. Further research is necessary to validate the age and origin of the house, as well as the architectural integrity of the interior, before a judgment can be made as to its eligibility.

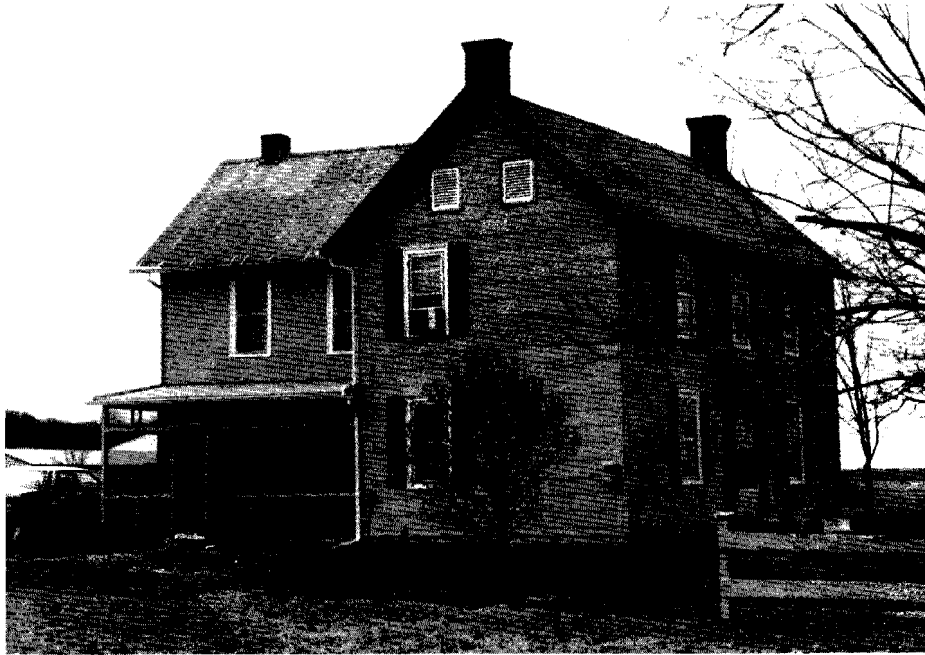
PLATE 255: CRS S-860

This property does not appear to be eligible either individually, or as part of the Three Bay, I-House, Multiple Property Submission. Alterations to the building's exterior include, louvered shutters on the windows and front door; a shed roofed, enclosed addition on the east facade of the rear wing, that has a band of two, modern picture windows; and the replacement of the small, attic story windows with ventilator openings. Although the house is in good condition, the above mentioned alterations coupled with the fact that there are no extant historic outbuildings, detract from the overall integrity of the house.

View of house looking southwest. The attic story windows have been replaced with ventilators and modern shutters have been added to all the windows.

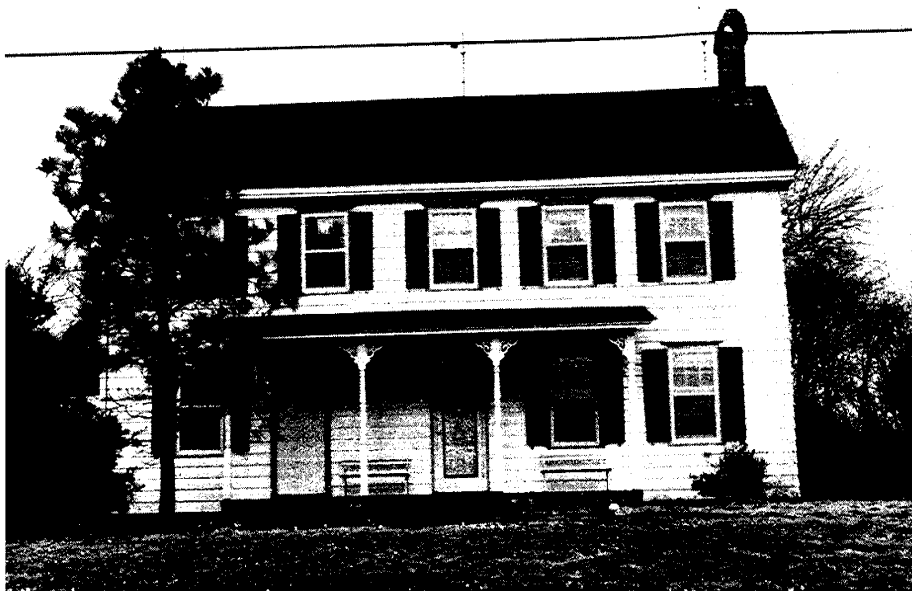
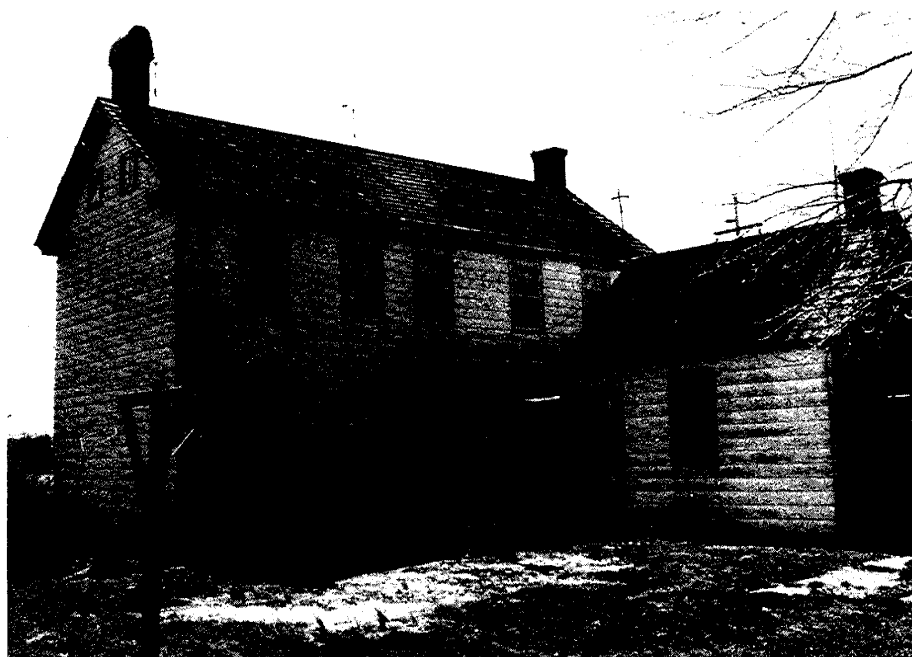
The sign in front of this house reads, "Cool Spring, formerly Big Maple Farm, patented 1740." The current house appears to date to the mid-nineteenth century. The house appears on an 1868 map of the area as belonging to J.L. Black (Beers 1868, Appendix B). The building is in good condition and retains many of its original architectural elements including: six over six, double hung windows with paneled shutters on the first floor and louvered on the second; a wooden, boxed cornice with returns; corbeled, brick chimneys; a transom over the front door; fixed windows in the attic story; and a brick foundation. In addition, the summer kitchen retains its wood siding, fenestration, and brick chimney. This property appears to be eligible as a contributing part of the proposed, Five Bay, I-House, Multiple Property Submission. It is one of seventeen examples of this architectural style in the study area. Nine of these seventeen were selected as the most representative of the style and were included in the multiple property submission. The five bay I-house is an unusual elaboration of the basic I-house and is an architecturally significant remnant of the built environment of Sussex County. The property is important within temporal period 1830-1880 and within historic context priority Agriculture (Ames et. al. 1989:83).

View of south facade facing Route 404. Note paneled shutters on the first story, six over six windows and louvered shutters in the second story.

View of rear or north facade. Note attached kitchen wing and corbeled brick chimneys.

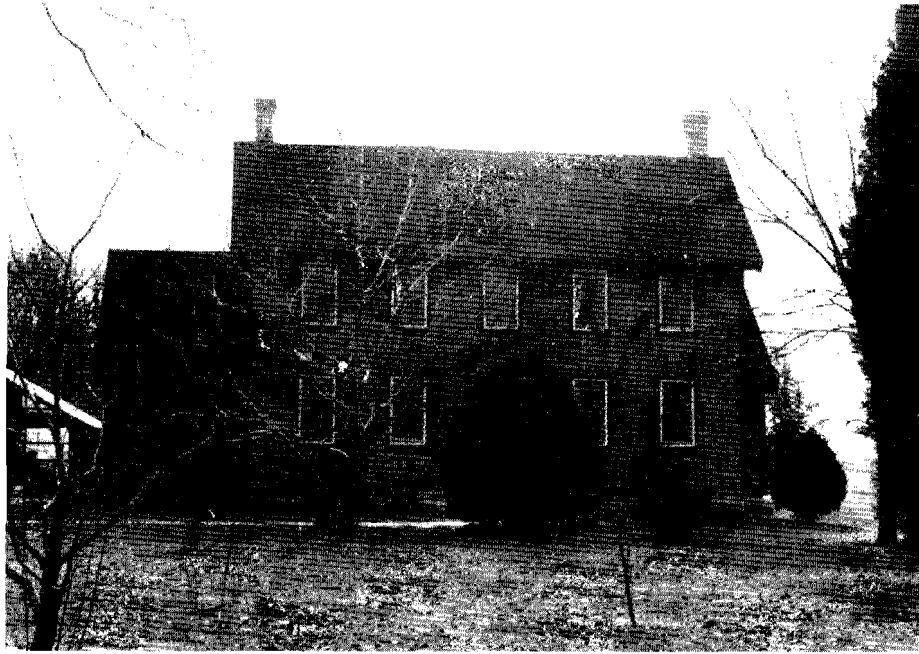
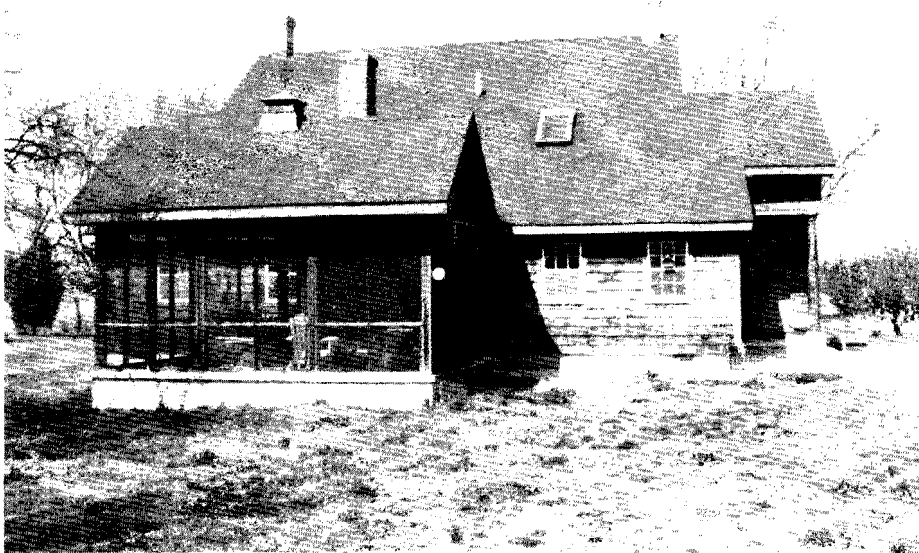
According to a previous survey, this house was moved back from the road recently and set on its new foundation. The current owner of the house has added a large, one and one-half story addition and a screened in porch on the rear or south facade. And has constructed a smaller, one and one-half story, one bay wide and deep addition on the east facade. Although the house is in good condition and retains its symmetrical, five bay front facade, the rear additions coupled with the fact that it has recently been moved, detract from the overall integrity of the structure, therefore preventing it from being an eligible property. There are several other five bay I-houses in the area that still retain their basic form, and contribute to a thematic district.

PLATE 257a: CRS S-865
View of front or north facade. Note corbeled brick chimneys and cedar siding.

PLATE 257b: CRS S-865
View of rear facade. Note large addition and screened in porch which detract from the symmetry of the house.

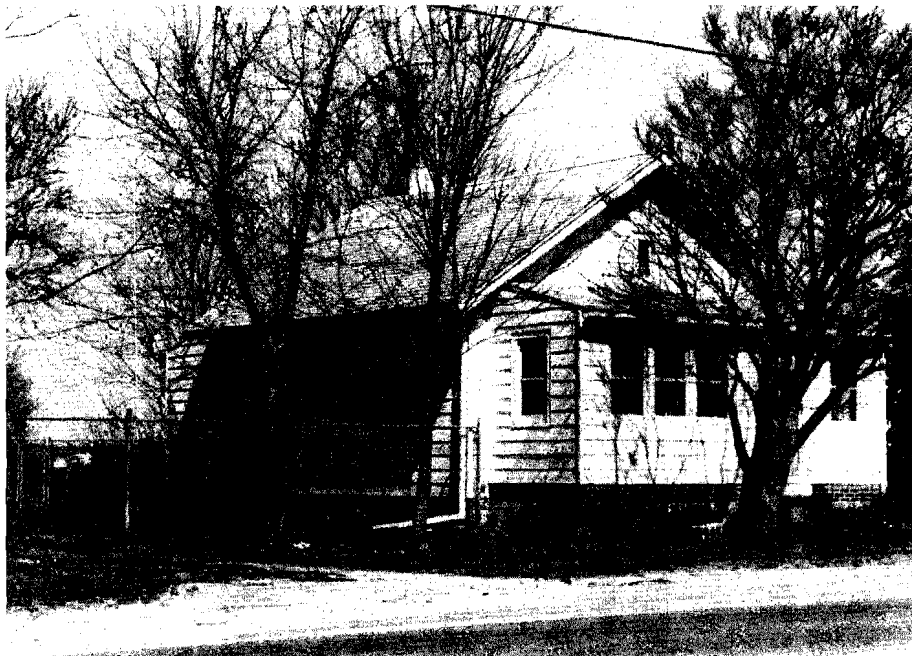
An interview with the tenant of this house in 1979, revealed that the structure had been built by a man with the last name, Harmon, and that a school once stood on the property. According to the tenant, the school was destroyed by fire and the brick foundations are still visible in the backyard (Hastings 1979). The resource form does not note the year the school burned down. Historic maps of the project area beginning in 1868, do show a schoolhouse on this property, continuing through 1941. In 1913, the school is labeled as the "Jones School," and in 1941, it is called the "Sunshine School" (Atkinson 1913 and Bausman 1941). The present building appears to date to the early twentieth century, and may be the second school building on the property. Due to the close proximity of this building to Belltown, it is possible that this was the site of an early black school in Sussex County. Further research is necessary into the history of this property, as well as the age and function of the current building, before a judgment as to eligibility can be made.

PLATE 258: CRS S-864
View of cottage looking northeast. Note brick foundation.

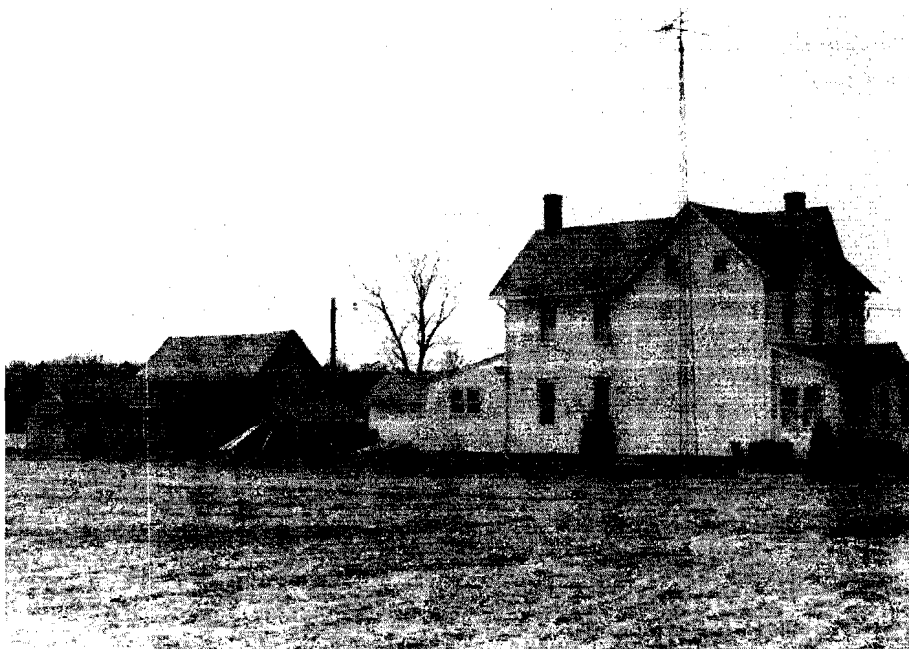
PLATE 259: CRS S-866
View of house and outbuildings looking southwest.

This complex is not eligible either individually or as part of the Three Bay, I-House, Multiple Property Submission. The basic form of the house has been compromised by the rear wing and surrounding porch as well as the enclosed front porch, that obscures the original first floor of the house. In addition, all of the windows in the first and second stories have been replaced with one over one, double hung sashes. Throughout the corridor, there are better examples of the three bay I-house form with greater integrity.

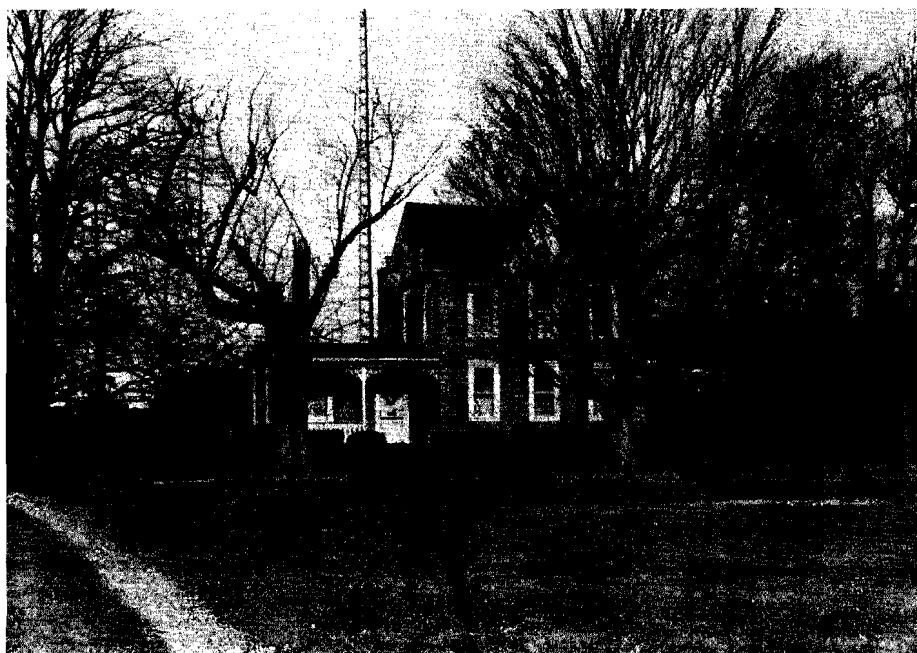
PLATE 260: CRS S-867

View of house looking north. Note cross gable in the front facade, two over two windows, and decorative posts on porch.

This complex appears to be eligible as part of the proposed, Three Bay, I-House, Multiple Property Submission. The house is in excellent condition. It retains many individual architectural elements such as the pointed cross gable in the front facade with a round window set in the peak; paired Italianate brackets along the cornice; six over six windows; and turned, wooden porch posts with carved scrollwork detailing. The additions on the house appear to be historic and do not detract from the overall integrity of the building. Three bay I-houses are significant remnants of the basic vernacular dwelling type found throughout Sussex County, and are important architecturally. The property is significant within the temporal period of 1830-1880, under the historic context of Architecture.

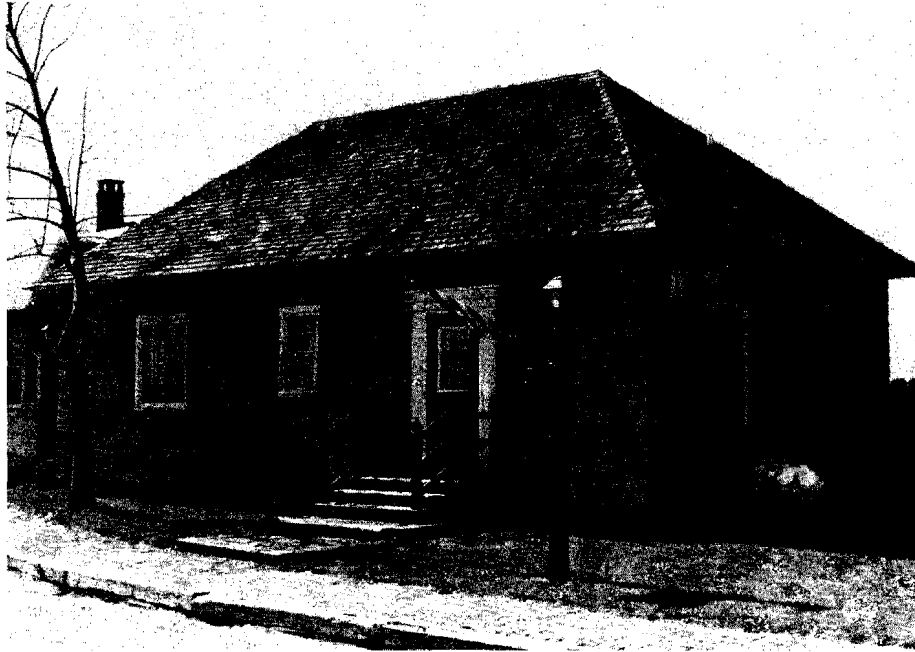
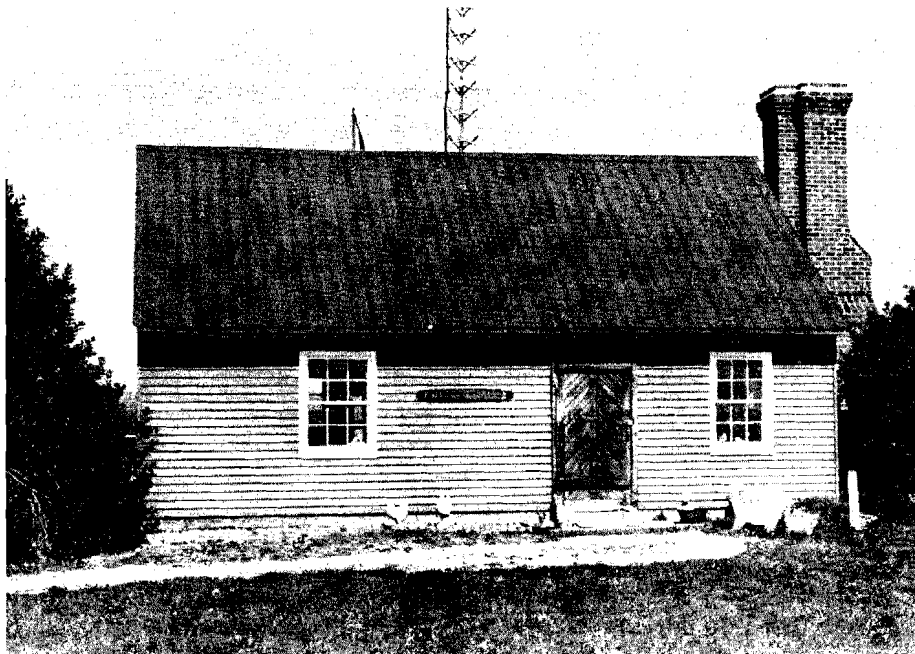
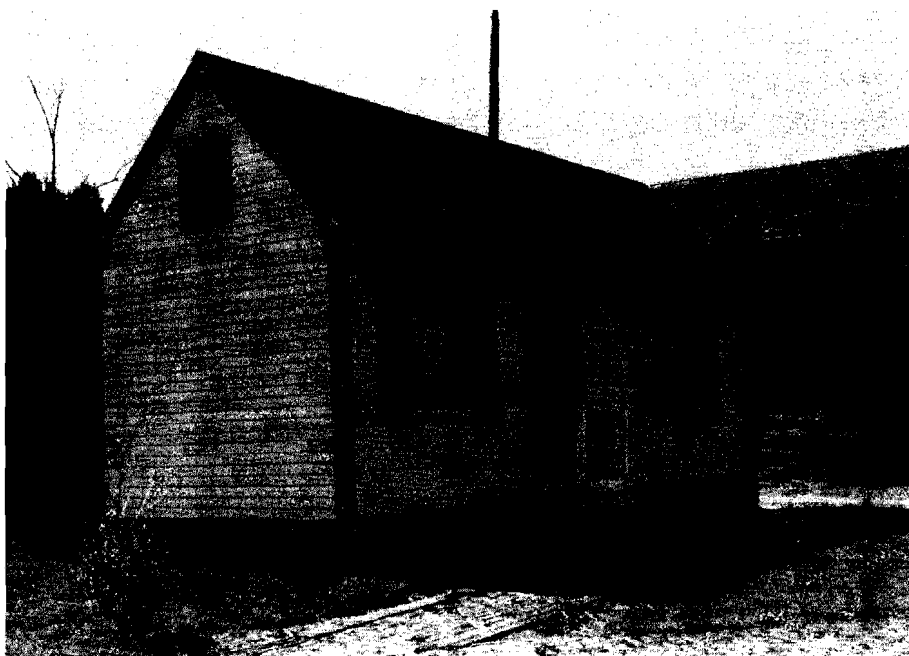
View of one of the historic buildings on the property currently used as a Day Care Center for children.

View of one of the historic buildings on the property. The structure is currently used as an office.

View of one of the historic buildings on the property. Note the dentil cornice, twenty pane windows and brick foundation. The current function of the building is unclear.

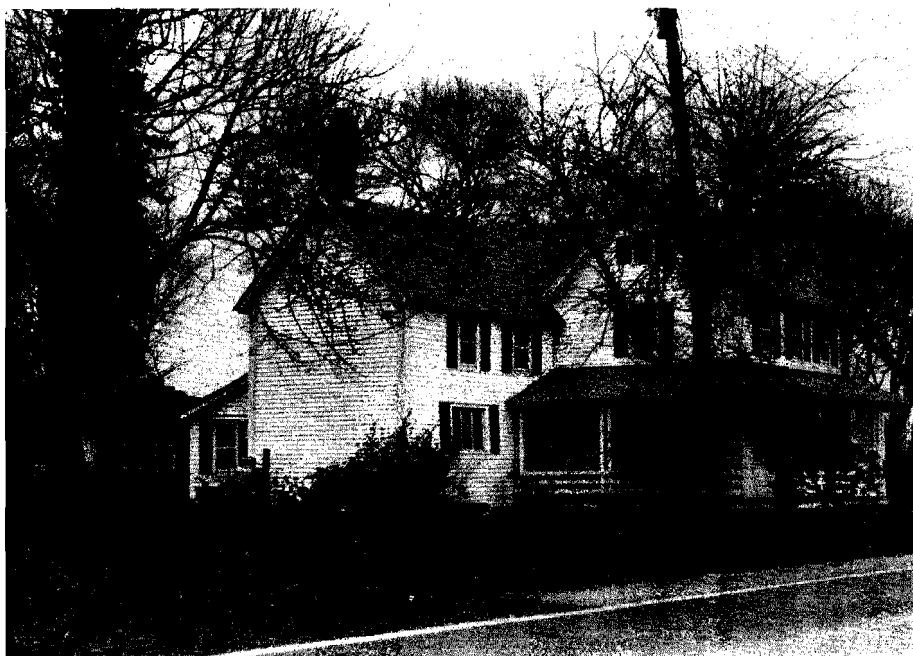
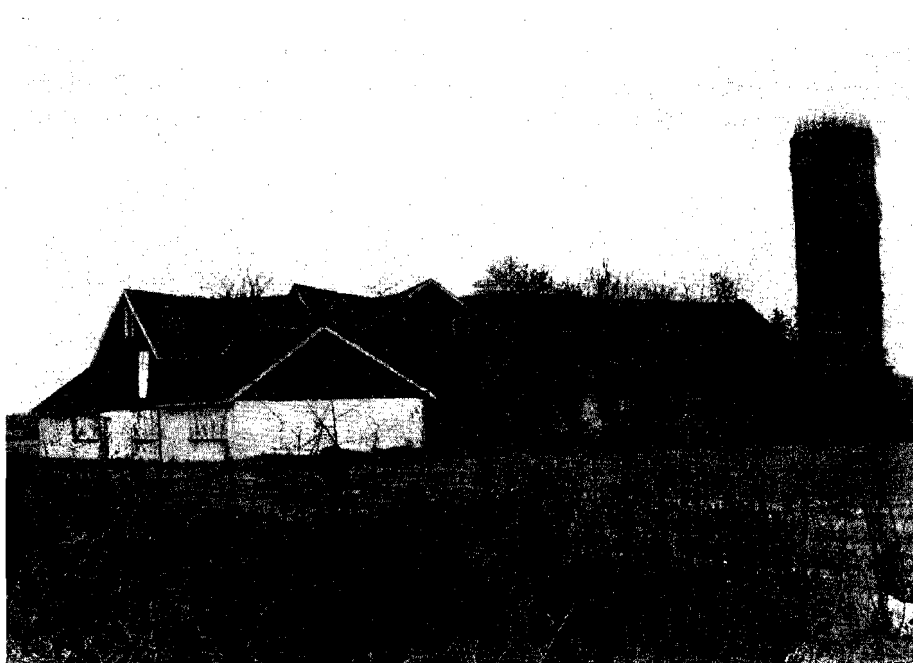
PLATE 263a: CRS S-900
View of house looking south. Note two distinct stages of construction.

PLATE 263b: CRS S-900
View of barn located across the road to the north of the house. This is the largest barn surveyed in the project corridor.

Directly across the road is a large barn, also constructed in various stages. This barn has at least three different sections, all with joining gable roofs. The main block of the barn is two and one-half stories with a gable roof running north to south. The building is approximately 225 feet long and 25 feet wide. The lower level is constructed of concrete block, while the upper story is vertical board. One story, gable roofed additions flank the northern end of the main barn. They appear to have been constructed at the same time as the original barn. A concrete silo is present along the east facade of the building. A concrete block, animal yard extends outward from this facade as well.

This property appears to be an individually eligible complex with a collection of intact nineteenth century agricultural related buildings and structures. The house is a symbol of various historic stages throughout the life of the property and is in excellent condition. The barn represents perhaps the largest and most unique form of barn construction found within the surveyed area. Although it is not currently used, it is in fair condition and warrants further study. The property is significant under the Priority Historic Context of Agriculture, 1830-1880 as defined in the Delaware Comprehensive Historic Preservation Plan (Ames et. al. 1989:83).

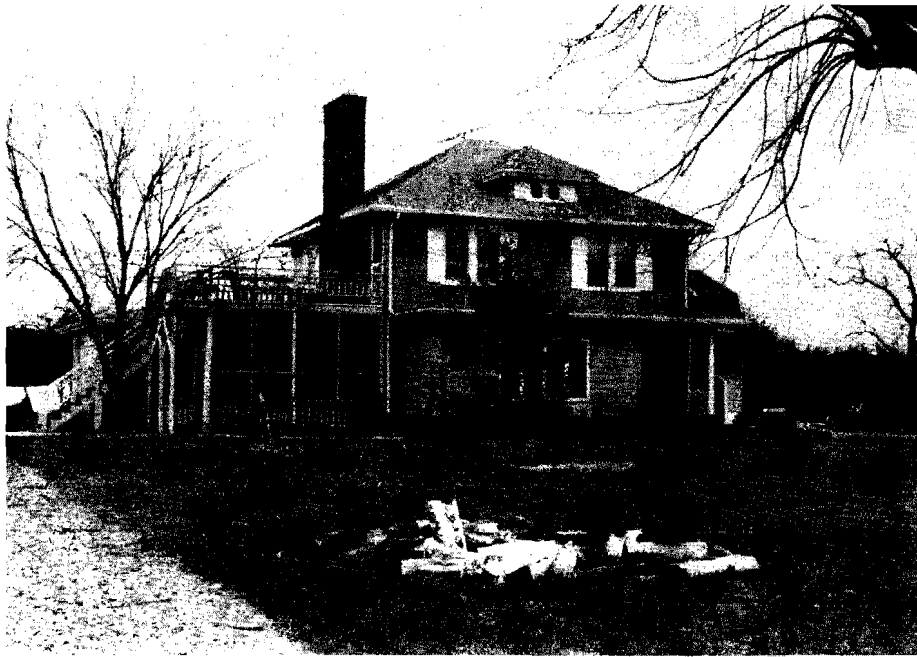
PLATE 264: CRS S-956

Currently both a dwelling and a hair salon, this building has been heavily altered. The first story windows on the front facade have been replaced by modern, picture windows. A modern, brick chimney and screened in porch with a sun deck, dominate the north facade. The one story, hipped roofed, wraparound addition also detracts from the overall form of the house. The house is not eligible either individually or as part of the proposed Classical Box, Multiple Property Submission. The Classical Box thematic district is characterized by the square plan and a general impression of symmetry, which this heavily altered house obviously lacks. There are better examples of the true Classical Box style found throughout the project corridor.

View of house looking east. Note changes in the fenestration and the construction of a modern deck and screened in porch on the north facade.

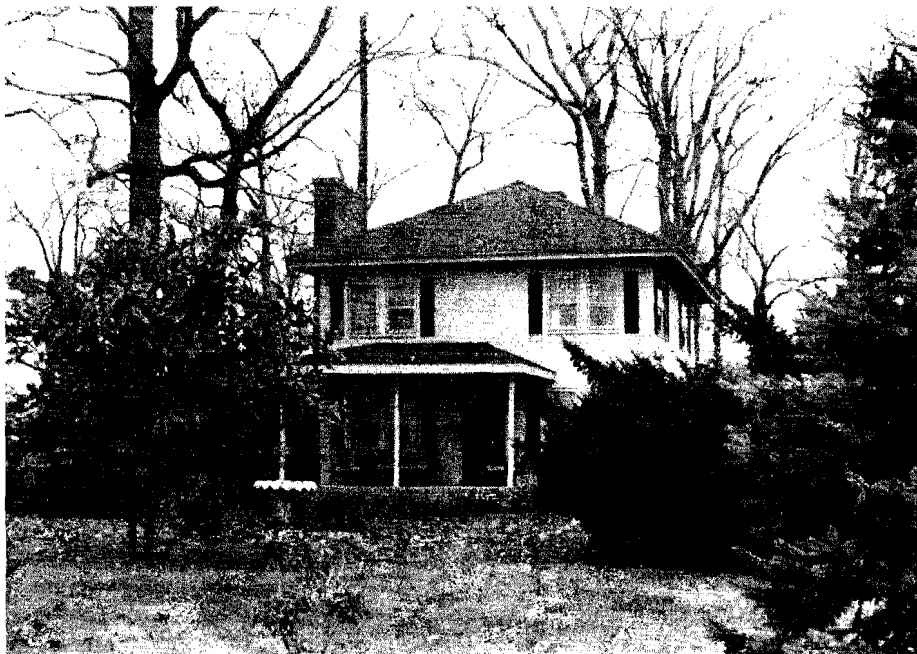
PLATE 265: CRS S-957

The house appears to date to circa 1910. The building is not eligible either individually or as part of the proposed, Classical Box, Multiple Property Submission. Changes in the form and fenestration detract from the overall simplicity of the original form. The Classical Box thematic district is comprised only of those examples retaining their square plan and general

View of house looking east. Note modern windows and brick chimney.

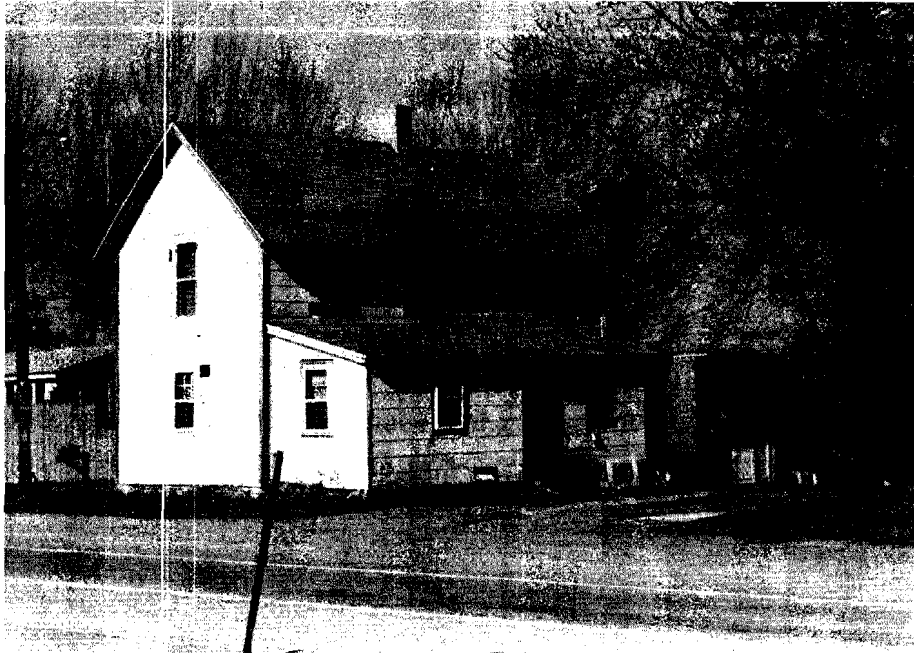
PLATE 266: CRS S-1042

View of house looking northeast. An enclosed section has been built across the entire south facade.

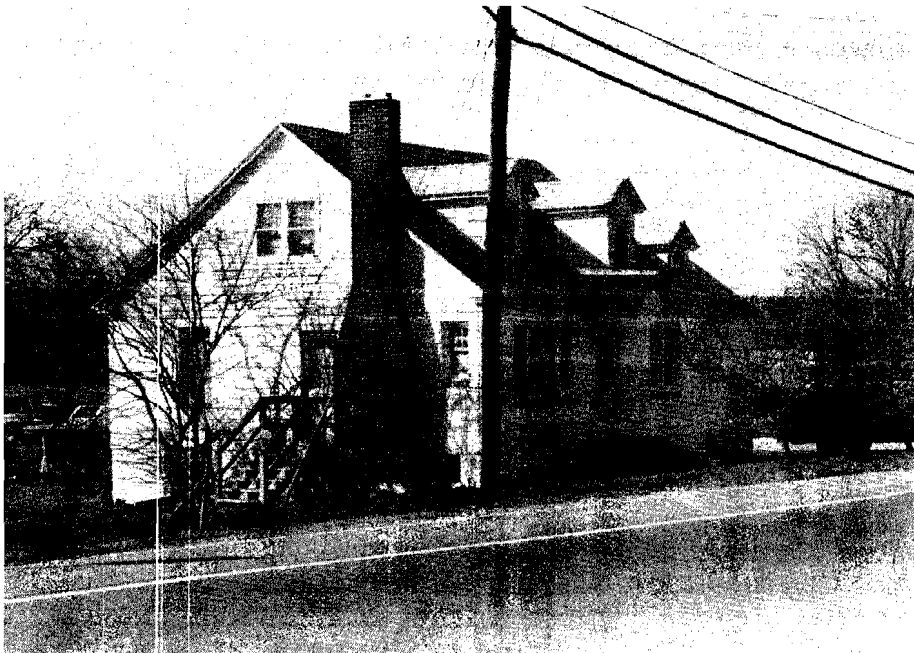
PLATE 267: CRS S-8514
View of house looking north.

This one and one-half story cottage is situated on the west side of Route 9, adjacent to Road 268, near Murrays Corner. The house is three bays wide and deep with a gable roof and two, gable roofed dormers in the front facade. The entrance is centrally placed in the front or east facade facing the road. A one and one-half story, two bay wide and one bay deep, gable roofed addition has been constructed on the north facade. The house is clad in a combination of frame and aluminum siding and rests on a concrete foundation. This cottage appears to post-date 1945. It lacks individual architectural merit or known historical significance, making it ineligible based on National Register criteria.

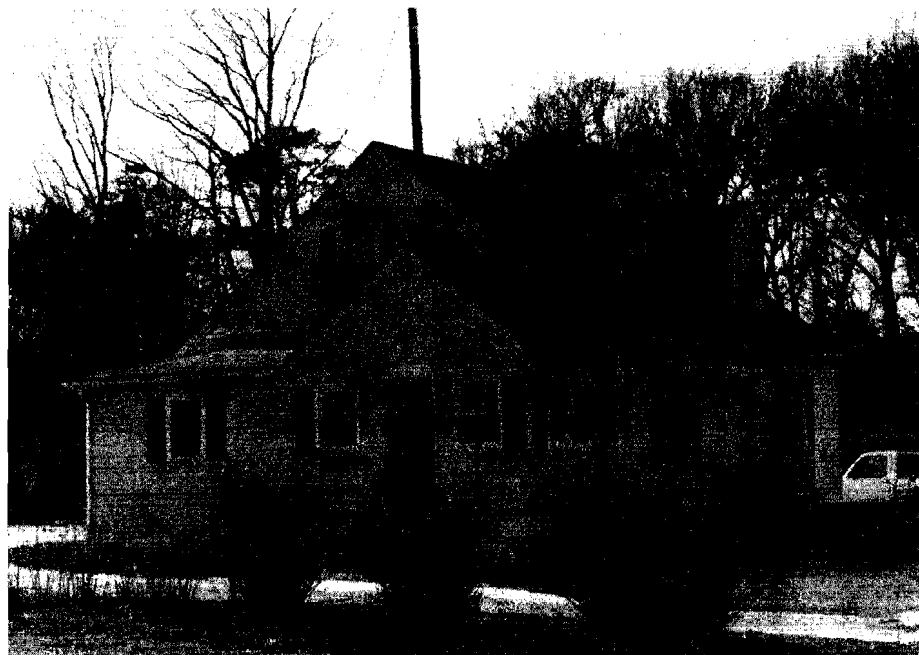
This twentieth century cottage is located on the west side of Route 1, next door to Lowes Hardware store. The house is one and one-half stories with a gable roof. It is three bays wide and two bays deep with an addition on the south facade. The entrance is centrally placed in the east or front facade, facing Route 1. Two, gable roofed dormers are evenly spaced in the upper story of the front facade. The house is clad in aluminum siding and rests on a concrete foundation. A one car, concrete block garage with a gable roof is situated behind the house to the west. This cottage appears to postdate 1945, and lacks individual architectural merit or known historical significance, making it ineligible based on National Register criteria.

PLATE 268: CRS S-8059
View of house looking northwest.
This building is located next to Lowe's Hardware Store on Route 1.
